Remediation of Skares Brickworks & Whitehill Colliery.

Case Study

Organic Waste Recycling

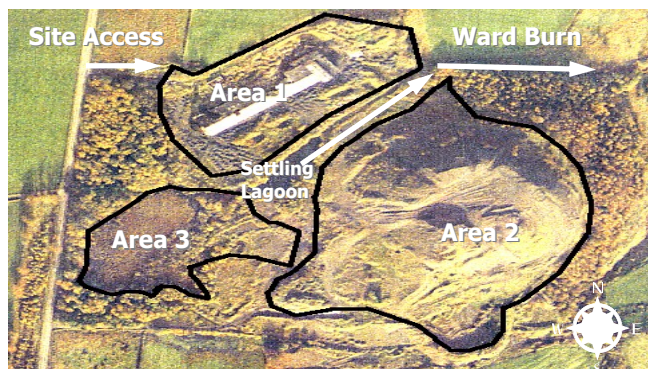
Figure 1: Site Areas Before Redevelopment

The former Skares Brickworks and Whitehill Colliery, occupying 12.5 hectares of Brownfield land, is located approximately 4 km west of Cumnock, between the A70 and the B7046, some 2 km north of the village of Skares in East Ayrshire. Digit Site Services purchased the land from local farmers in 2000. The site consisted of three main areas see Figure 1:

Area 1. The former Skares brickworks, approximately 3 hectares, was operational from the late nineteenth century until 1962.

Area 2. A spoil heap arising from the dismantled Whitehill Colliery which closed in 1963.

Area 3. Former agricultural land and woodland degraded by flooding from spoil heap water run-off.

The site characterisation work identified spoil heap (Area 2) water run-off had been directed to the settling lagoon prior to discharging via a ditch and outfall to Ward Burn off-site, see Figure 1. Lack of maintenance since colliery closure led to silting, and overflow. As a result a second lagoon and marshy wetland (Area 3) became established to the south.

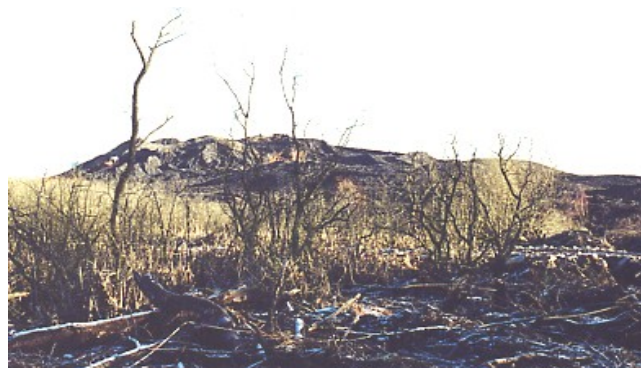
Figure 2: Fifteen Year Old Trees With Stunted Growth

Trees had colonised some parts of the spoil heap, however the lack of nitrogen and phosphorous in the soil reduced the growth rate and prevented natural seeding, see Figure 2.

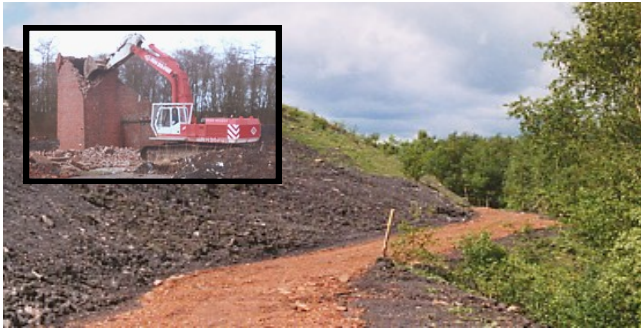
Figure 3: Demolition of Brickworks & Construction of Paths

Work began with the demolition of the old brickworks building. The brick and concrete was crushed and used to form the paths and viewpoints which pedestrians will use after completion of the VMSR regeneration programme, see Figure 3. Representatives of the local communities were encouraged to visit and view the operations under proper supervision.

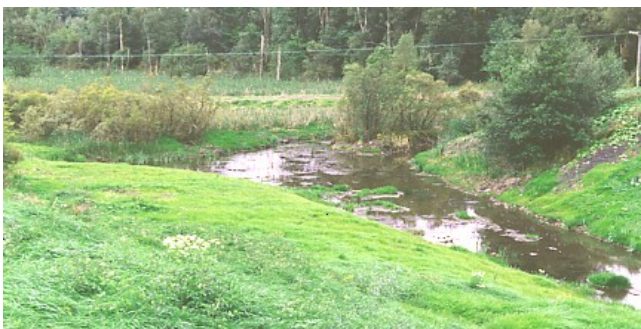
Figure 4: Dredged Settling Lagoon & Drained Area 3

The silted settling pond and outlet was excavated to the clay beds. This process increased the capacity to store surface water run-off and immediately alleviated the flooding in Area 3 shown in the background of Figure 4.

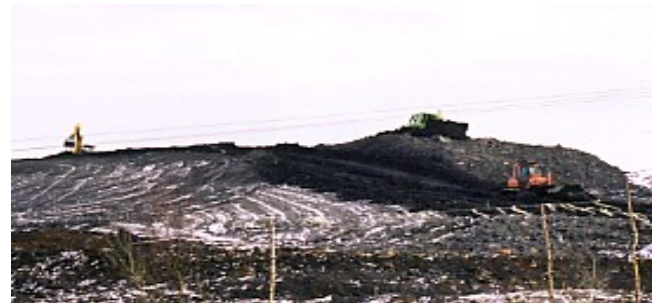
Figure 5: Shaping of Contours

The field trials identified that the VMSR method could be used to remediate the site with an optimum design mix of 3:1 of blaes/shale to sewage sludge cake respectively to a suitable rooting depth. Full scale soil remediation and contour formation took place from August 2000—February 2002.

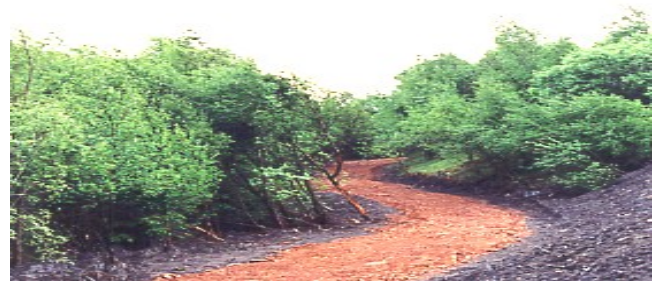
Figure 6: Tree Planting Completes The Site Regeneration

On completion of the project, 50,000 tonnes of sewage sludge filter cake was diverted from landfill and used for ecological and environmental benefit. Flooding has also been eliminated due to the improved drainage on site. To sustain this, mixed woodland and grass was planted over the entire site thereby reducing soil run-off and lagoon silting, see Figure 6. The regenerated woodland and wetland is now a rich habitat for a range of animals and birds.
